STRUCTURAL PERFORMANCE TEST REPORT

COLOR GUARD - A DIVISION OF POLY VINYL COMPANY

PRODUCT: 5" x 5" Storm Collar Post Bracket

Report No: 68888.01-119-16 Report Date: 01/19/07

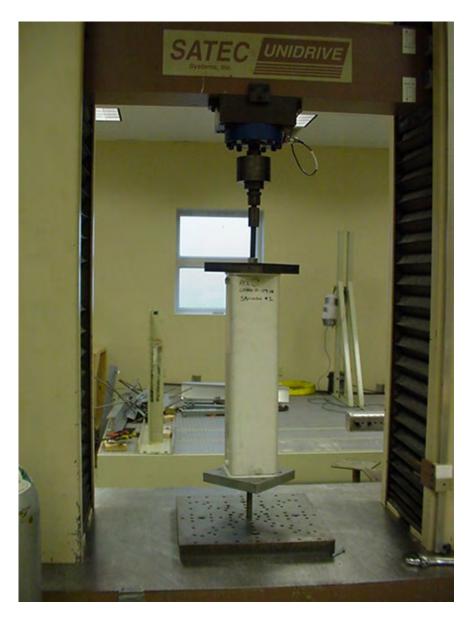
Photo No. 1 Uplift Resistance Test Setup

Equipment: For the uplift strength tests, the specimens were tested to ultimate capacity in tension utilizing a SATEC model 50UD universal test machine.

Uplift Load Test Procedure: Each test specimen was inspected prior to testing to verify size and general condition of the materials, assembly and installation. No potentially compromising defects were observed prior to the load test. After securing each column into the test machine, the load was applied at a uniform rate (0.05 in/min) until the ultimate load capacity was reached.
